Safety Inspection Report

Annual Inspection

Westonfields Recreation Ground

Albury Parish Council

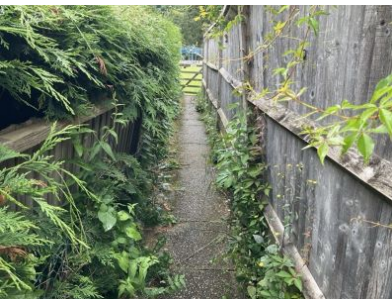
Encroaching vegetation or trees.

Cut back at the approach pathway.

Read the notes for further action.

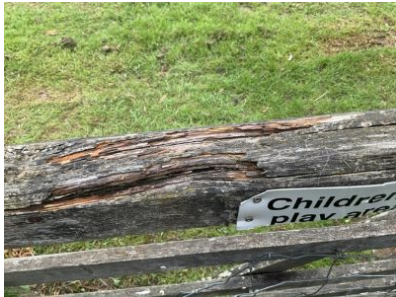
Timber is decayed.

Entrance gate.

6

Replace affected parts.

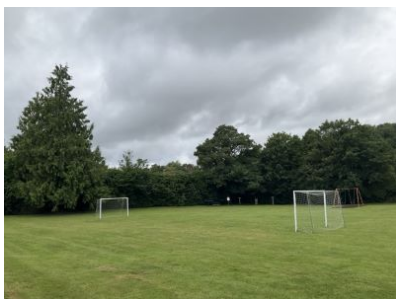
Item was not inspected on this occasion.

Ensure a proper inspection is conducted at the appropriate time.

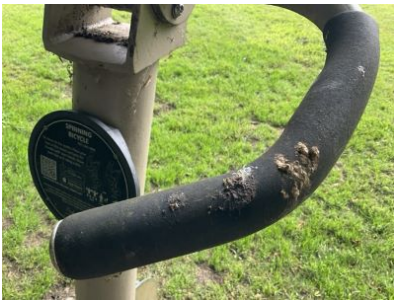
Bird fouling present.

Ties not practical on this asset. Clean down.

6

It is recommended that playground equipment be regularly checked for bird fouling - if found, the affected items should be cleaned with a disinfectant solution.

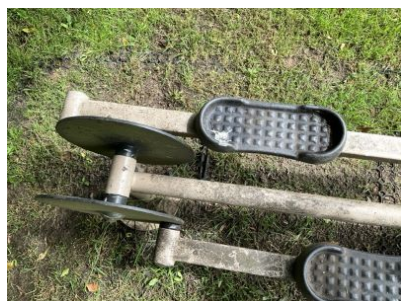
Bird fouling present.

Risk score:
8

It is recommended that playground equipment be regularly checked for bird fouling - if found, the affected items should be cleaned with a disinfectant solution.

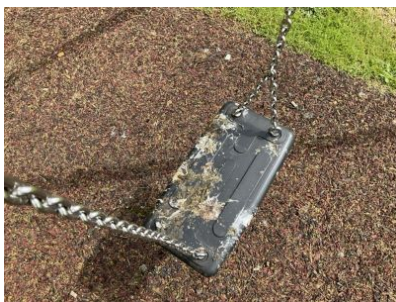
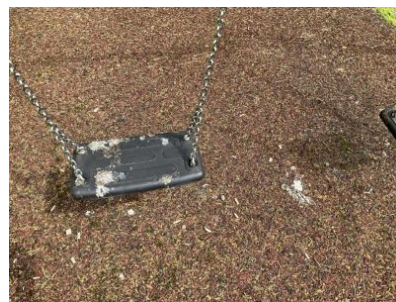
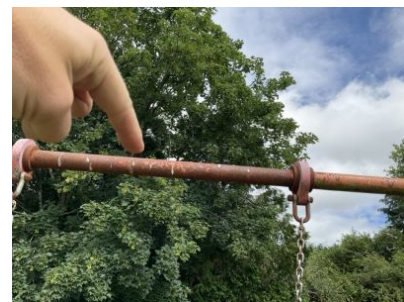
Bird fouling present.

8

Consider fitting an anti-bird strip or upward-facing cable ties to the top bar to prevent birds from landing.

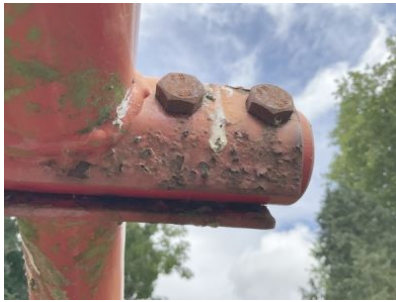
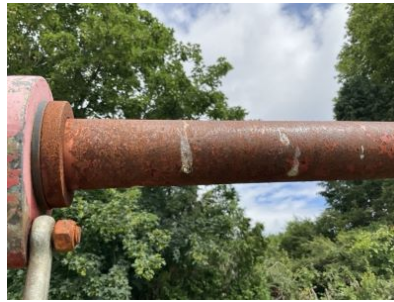
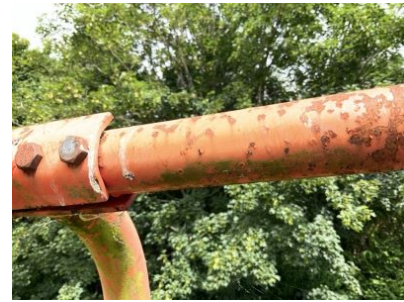
Item is rusting in places.

6

Descale.

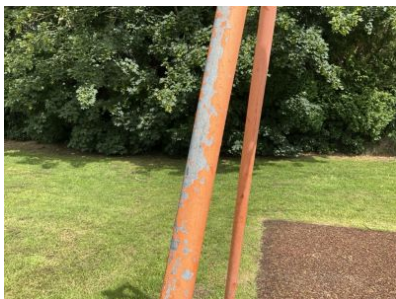
Paintwork is in poor condition.

5

De-scale back to good base material and coat with lead free paint, using appropriate precautions. Repairs may be necessary where corrosion is severe.

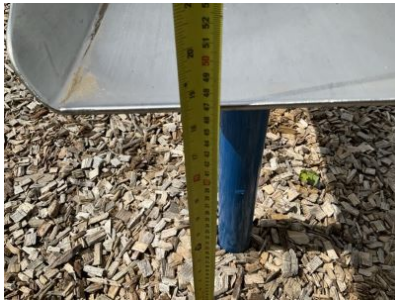
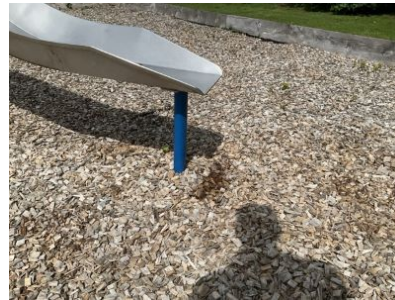
The height of the end of the slide run-out is greater than that allowed.

8

The slide is installed correctly, but there is insufficient depth of loose-fill material to maintain the correct slide run-out height. Top up the loose-fill.

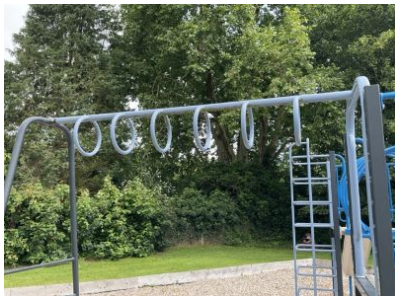
Overhead ladders and rings provide significant play value and benefits to children, and with it the risk of falling. Ensuring the surface remains in good condition will help to keep the correct balance between benefits and risk.

8

If possible, on angled or S-shaped bars, consideration should be given to level bars with firm grips and even spacings. The protective surface under all bars and rings must be kept in good condition.

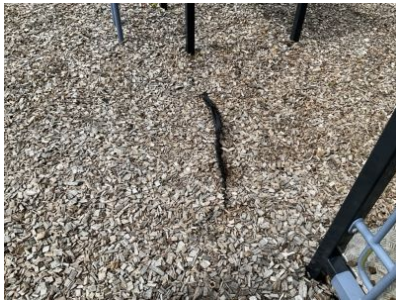
The geo-textile is exposed.

6

Secure beneath surface and ensure minimum depths are maintained.

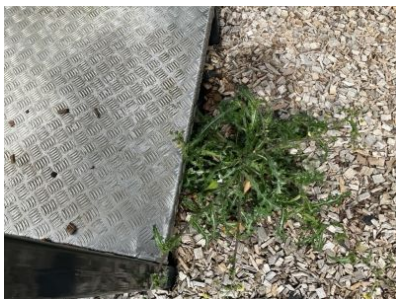
Surface has unintended weeds.

6

Remove.

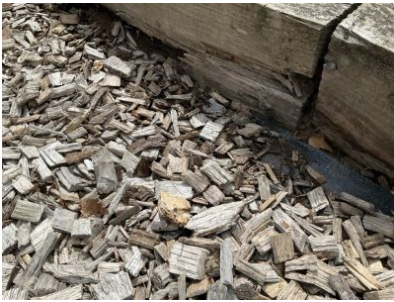
Timber is decayed.

6

Check on a routine basis.

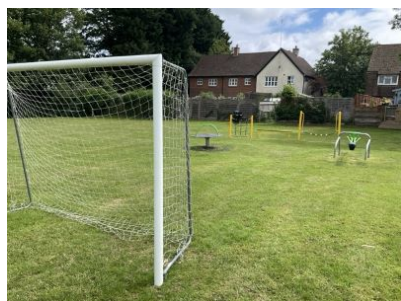
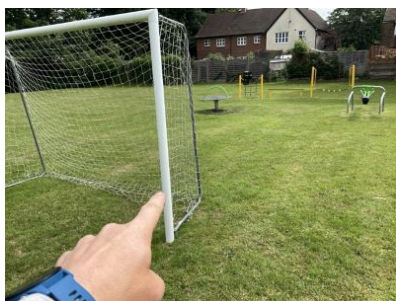
Fitness equipment has been installed in the immediate vicinity of children's playgrounds without being separated from general playing activities by an appropriate distance, fencing or other structural measures.

9

Relocate equipment.

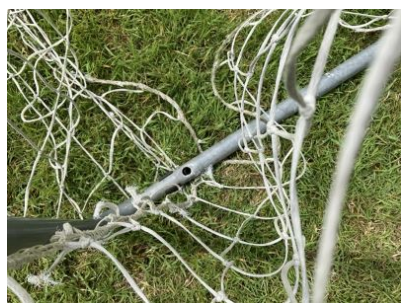
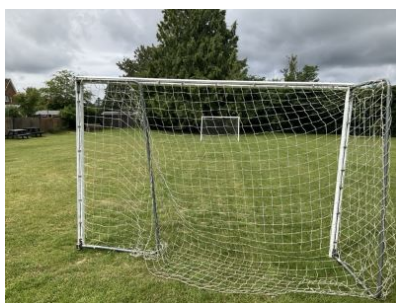
Fixtures loose or missing.

8

The goals fold up and therefore can be folded and pushed flat. They are in the wrong position immediately behind them. See separate finding. They should be secured, but in this setting it is difficult to find a reasonable space for them.

Tighten/replace.

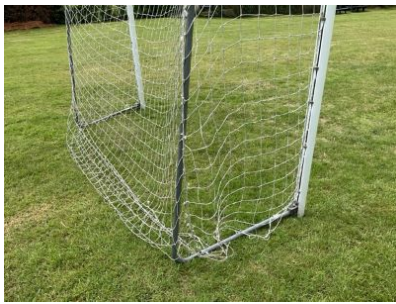
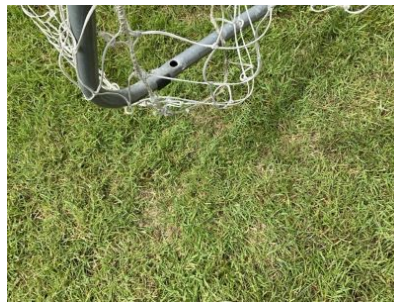
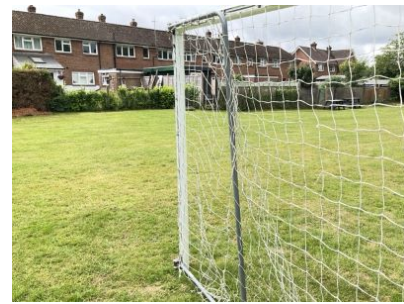
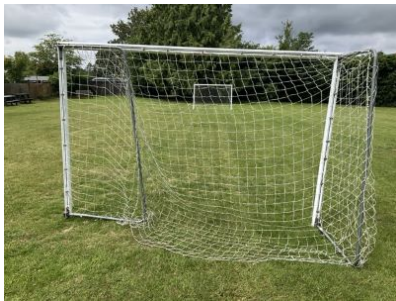
Item is not secure.

8

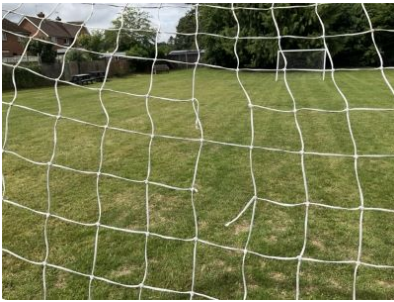
The netting is damaged.

6

Repair.

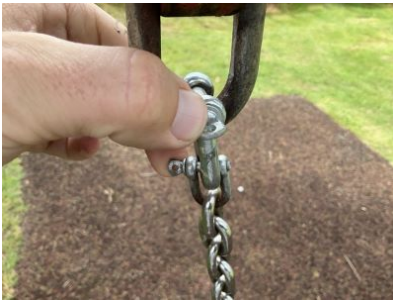
6

It is recommended that an alternative type of shackle that does not have sharp ends be used. Use fixings compliant with EN 1176.

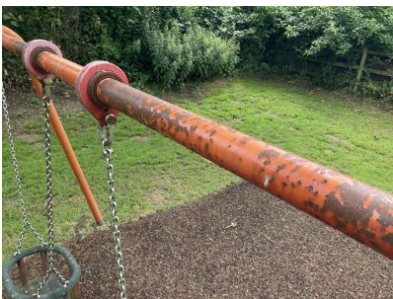
Item is rusting in places.

6

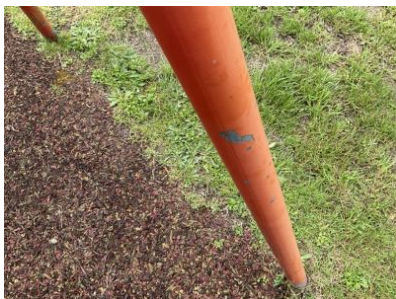
Paintwork is in poor condition.

5

De-scale back to good base material and coat with lead free paint, using appropriate precautions. Repairs may be necessary where corrosion is severe.

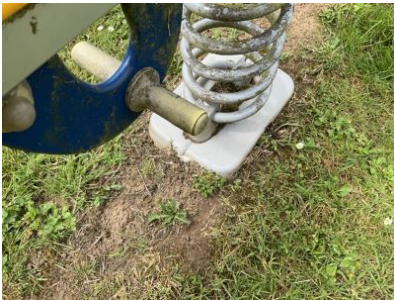
Description	Tasks	Risk score
The equipment is dirty or algae covered.	Clean off.

3

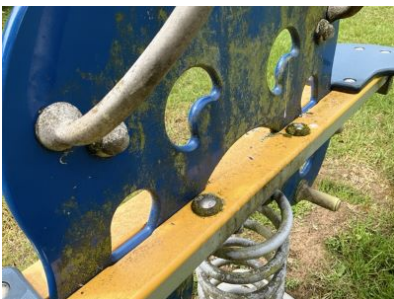
4
Protruding handles / foot rests.	The unit was installed prior to the publication of the current standards. There is no requirement to make retrospective changes.

4
