# Safety Inspection Report

Annual Inspection

## Westonfields Recreation Ground

16 July 2024

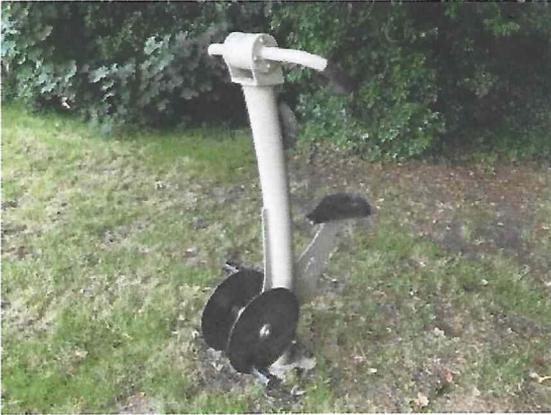
# Adult Fitness - Exercise Bike

Bird fouling present.

Ties not practical on this asset. Clean down.

Low

6

It is recommended that playground equipment be regularly checked for bird fouling - if found, the affected items should be cleaned with a disinfectant solution.
