Safety Inspection Report

Annual Inspection

Westonfields Recreation Ground

Albury Parish Council

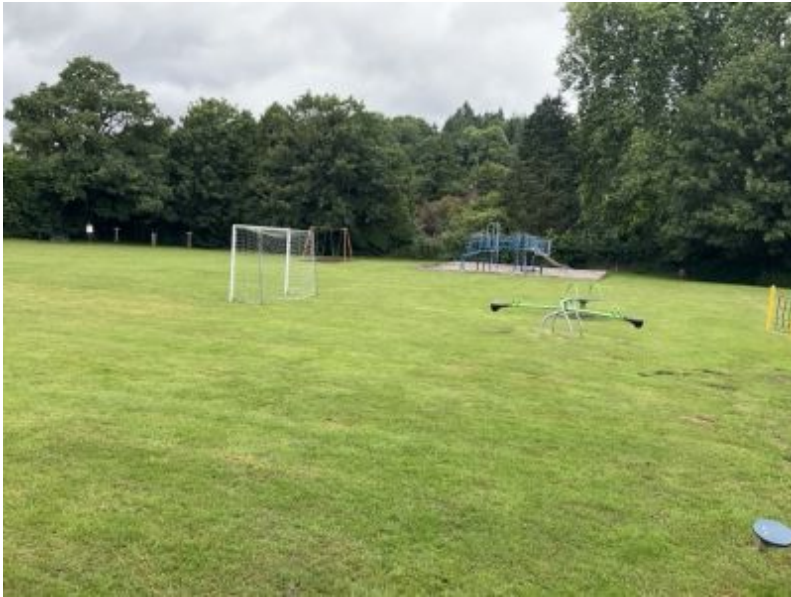
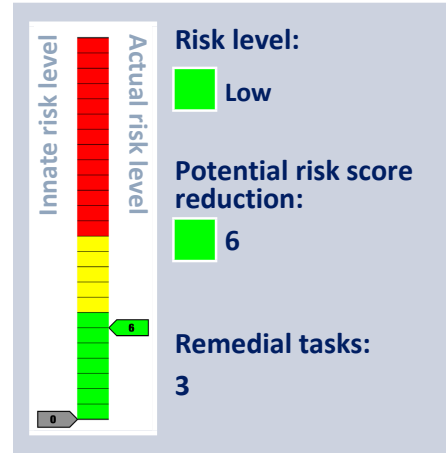
The Overall Site

Timber is decayed.

Replace affected parts.

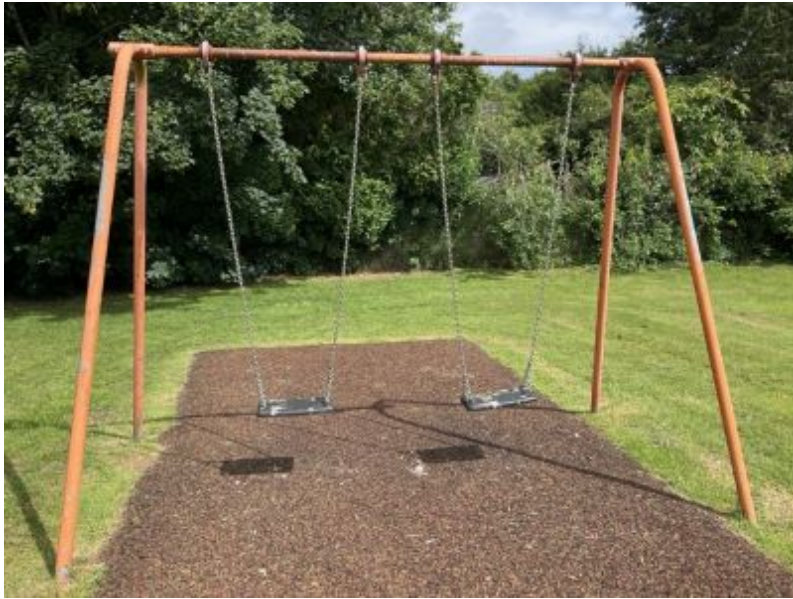
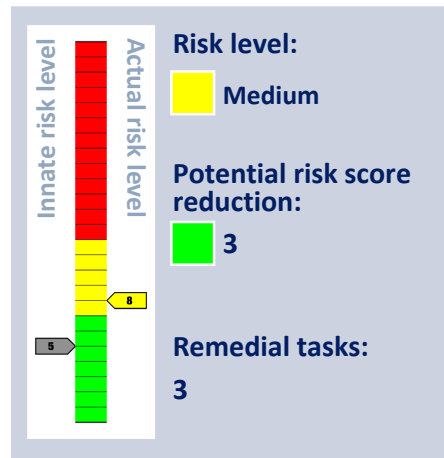
Swing - Junior - 1 Bay 2 Seat

Item is rusting in places.

Paintwork is in poor condition.

De-scale back to good base material and coat with lead free paint, using appropriate precautions. Repairs may be necessary where corrosion is severe.

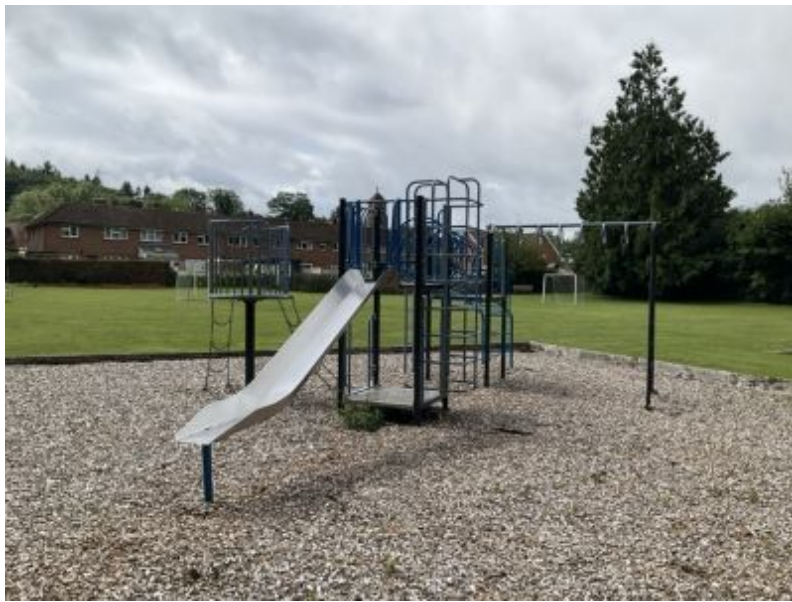
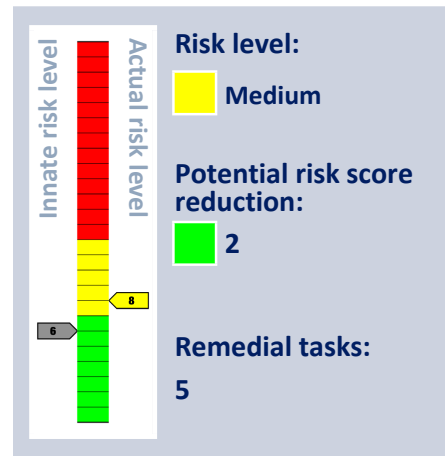
Multiplay - Slide Climber

1. Overhead ladders and rings provide significant play value and benefits to children, and with it the risk of falling. Ensuring the surface remains in good condition will help to keep the correct balance between benefits and risk.
2. The geo-textile is exposed.
3. Surface has unintended weeds.
4. Timber is decayed.

Timber is decayed.

The slide is installed correctly, but there is insufficient depth of loose-fill material to maintain the correct slide run-out height. Top up the loose-fill.

Overhead ladders and rings provide significant play value and benefits to children, and with it the risk of falling. Ensuring the surface remains in good condition will help to keep the correct balance between benefits and risk.

If possible, on angled or S-shaped bars, consideration should be given to level bars with firm grips and even spacings. The protective surface under all bars and rings must be kept in good condition.

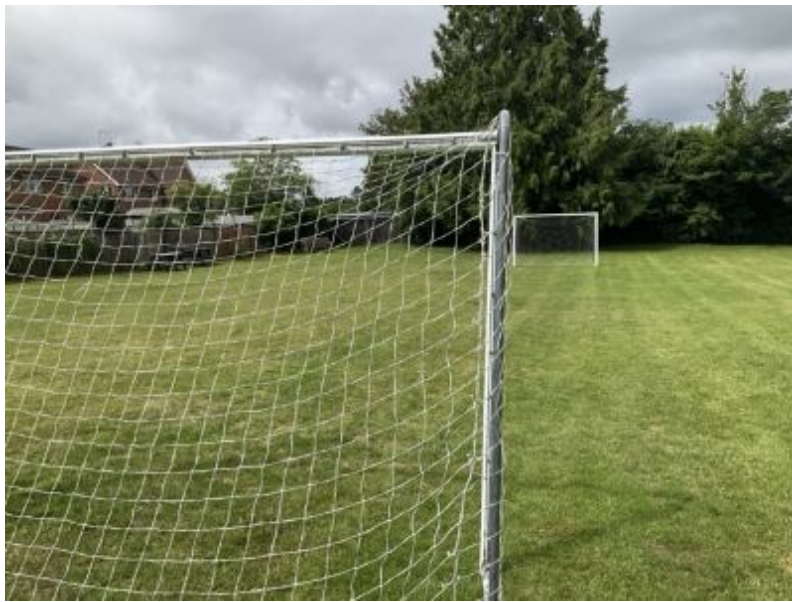
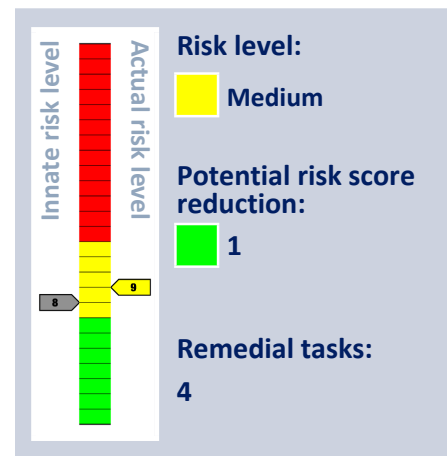
Goals

1. Fixtures loose or missing.
2. Item is not secure.
3. The netting is damaged.

Fixtures loose or missing.

The netting is damaged.

Tighten/replace.

Repair.

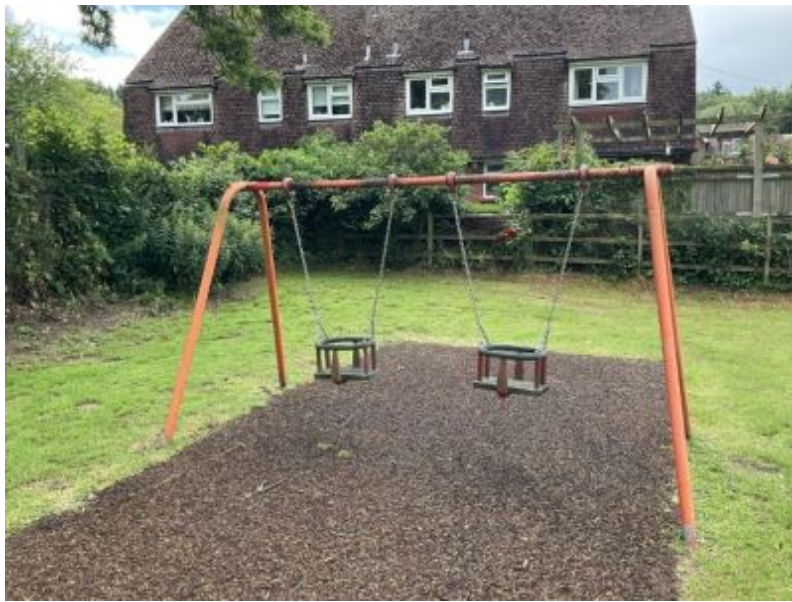
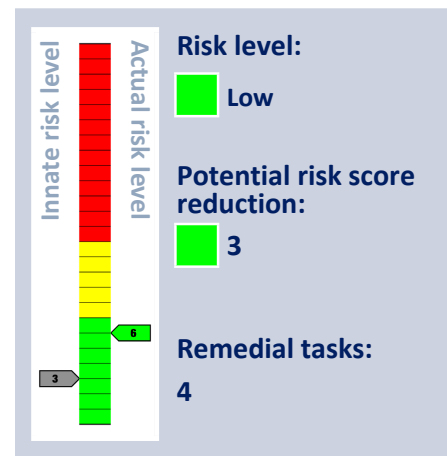
Swing - Toddler - 1 Bay 2 Seat

1. Item is rusting in places.
2. Surface has unintended weeds.
3. Paintwork is in poor condition.

Item is rusting in places.

Paintwork is in poor condition.

It is recommended that an alternative type of shackle that does not have sharp ends be used. Use fixings compliant with EN 1176.

De-scale back to good base material and coat with lead free paint, using appropriate precautions. Repairs may be necessary where corrosion is severe.
